RECALL CAMPAIGN

n° E/01/02 pg. 1/4 2nd May 2002

Models : California EV-Jackal-Special

Objects : Throttle control

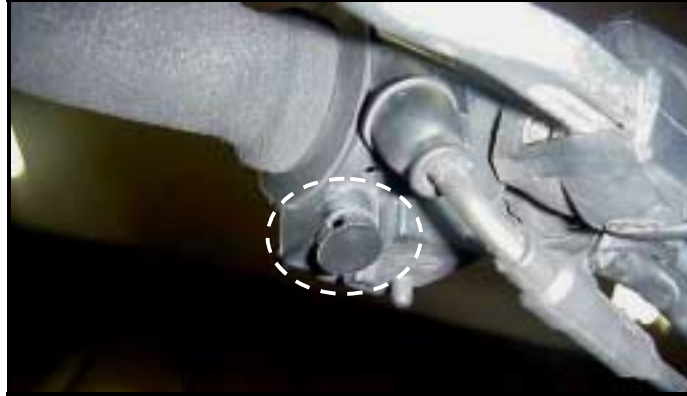
1

1. With the use of pliers remove the plastic cap that occlude housing of the recovery cable for gas transmission (1).

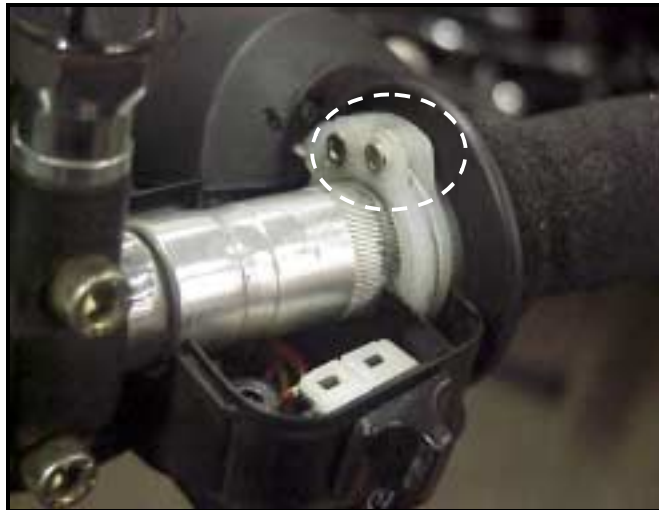
2

2. With the use of a proper screw tap (12X1) thread the housing internal part.
3. Disassemble the twist-grip handle control, insert the end of the wire in its proper seat (2) and then screw the threaded part of gas transmission in its housing (3).

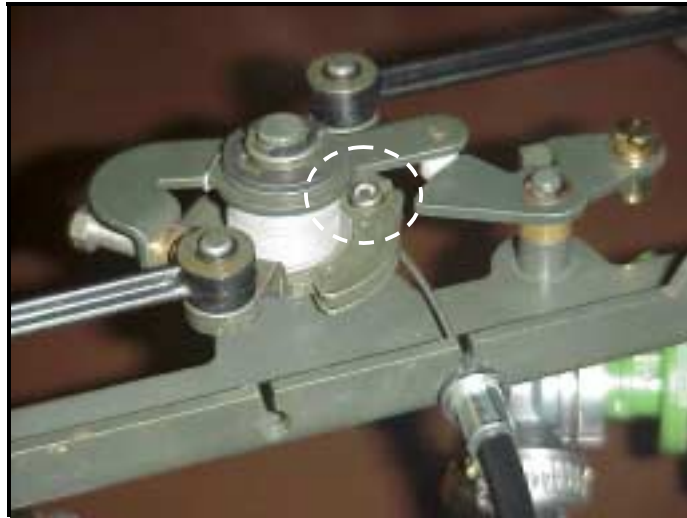
4

4. Remove the saddle and the tank so that you can work free on part between throttle valves.
5. Go through the end of the gas transmission till it reaches it's proper housing positioned on the gear between throttle valves than fit the second end of the wire (4).
