Model: Moto Guzzi 1200 8V engines

Subject: Operations on valve bucket tappets

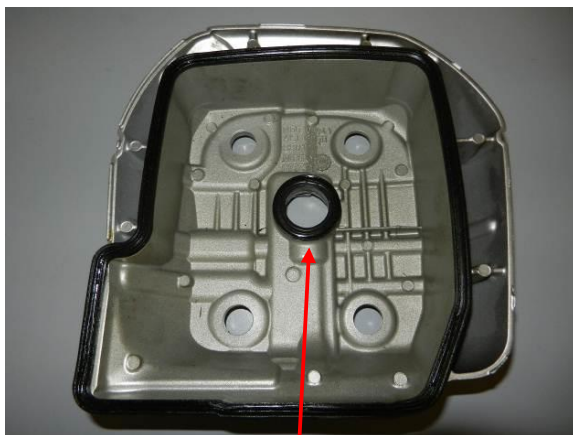
OK

To verify whether the vehicle can be modified with **kit A** remove the timing cover and check whether it is the floating type, which can be recognised by the presence of the circlip in the spark plug hole area:

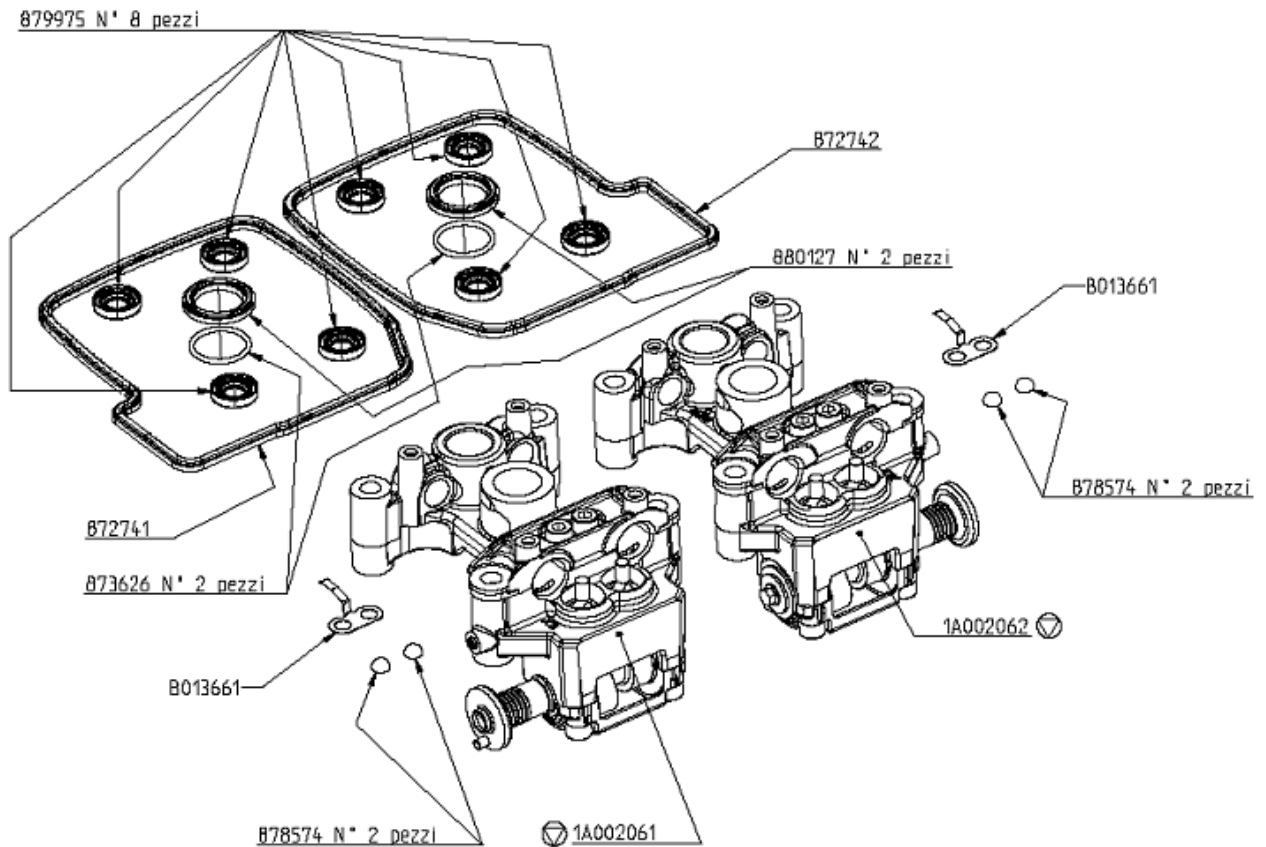
The **KIT A P/N 1A002060** is comprised of the following parts:

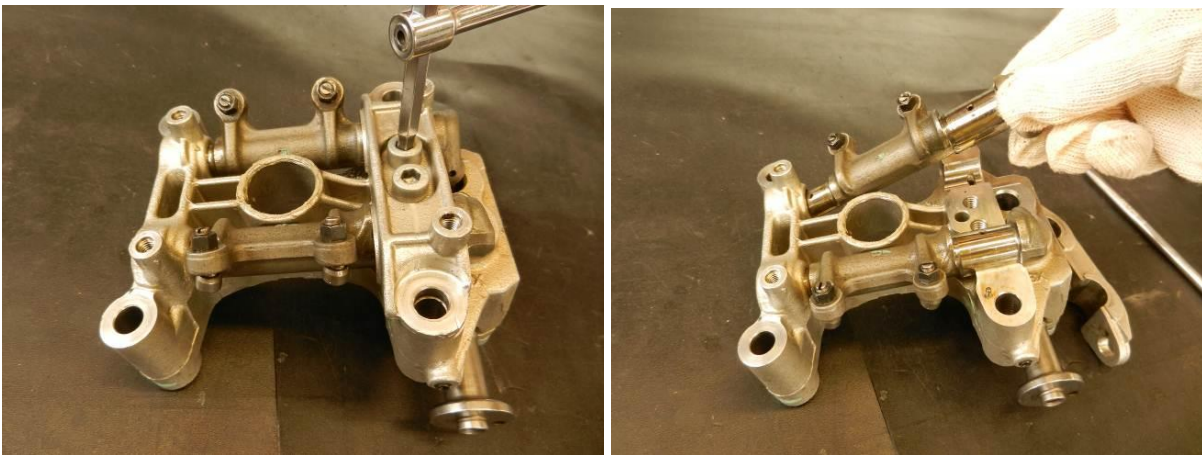
Remove the rockers mount and delicately slide them from their seat.

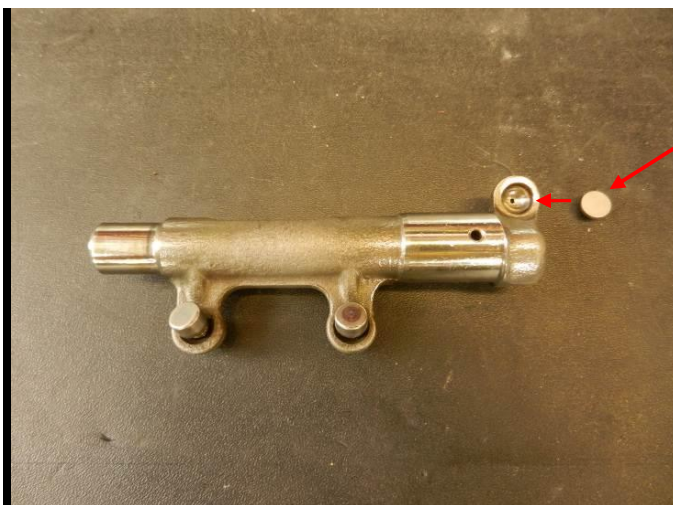
Place the pads P/N 878524 in the relative seats with the aid of a layer of grease so that they hold the position.

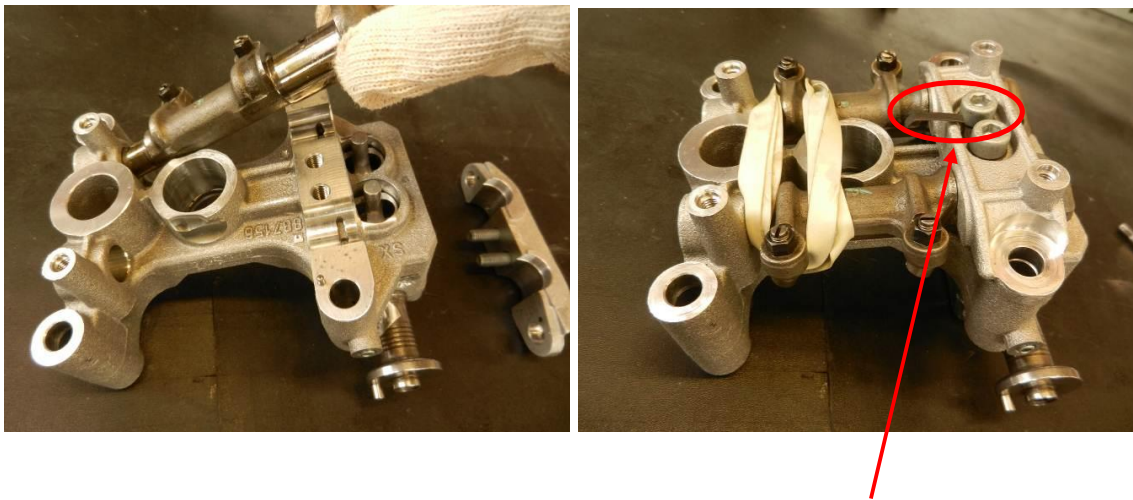
P/N B013661

Fit the old rockers in the **new** cam tower, fasten the rocker retainer cap, installing the **new** ground plate **part No. B013661** between the retainer cap and the fastener screws (tightening torque 18 Nm);

Note: in order to ensure that the rockers stay in their seat, bind the rockers temporarily with an elastic band

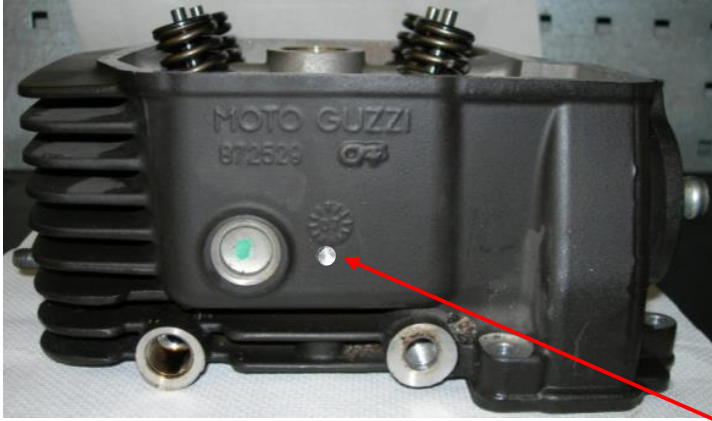
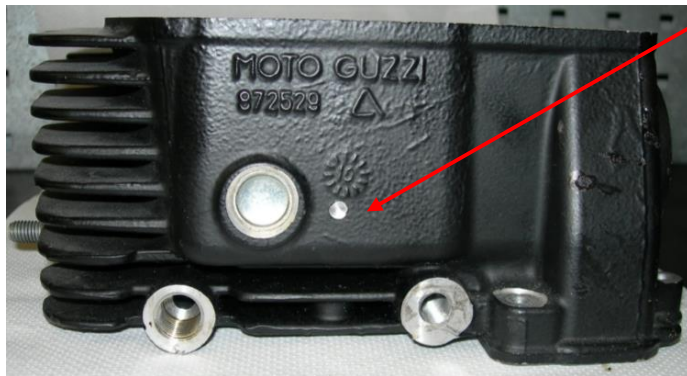
Then check the following:

If the marking is present, use **KIT B**

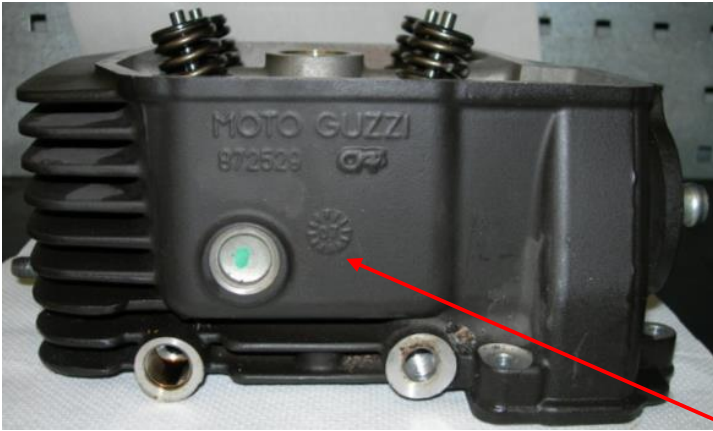
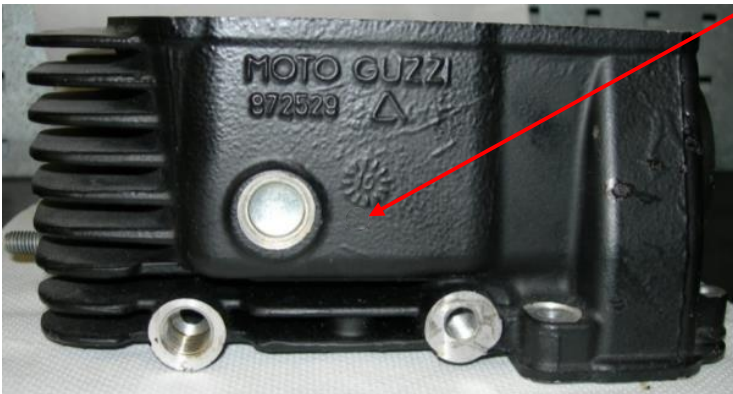
If there is no marking, use **KIT C**

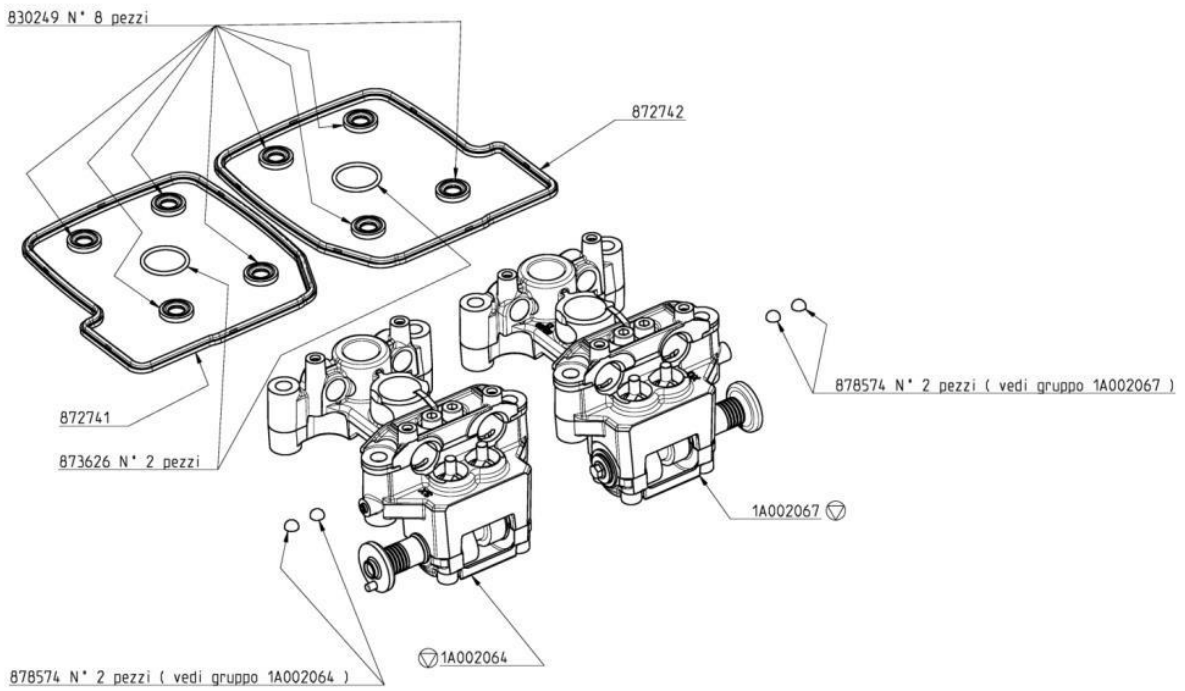
KIT B, P/N 1A002063, consists of the following components:

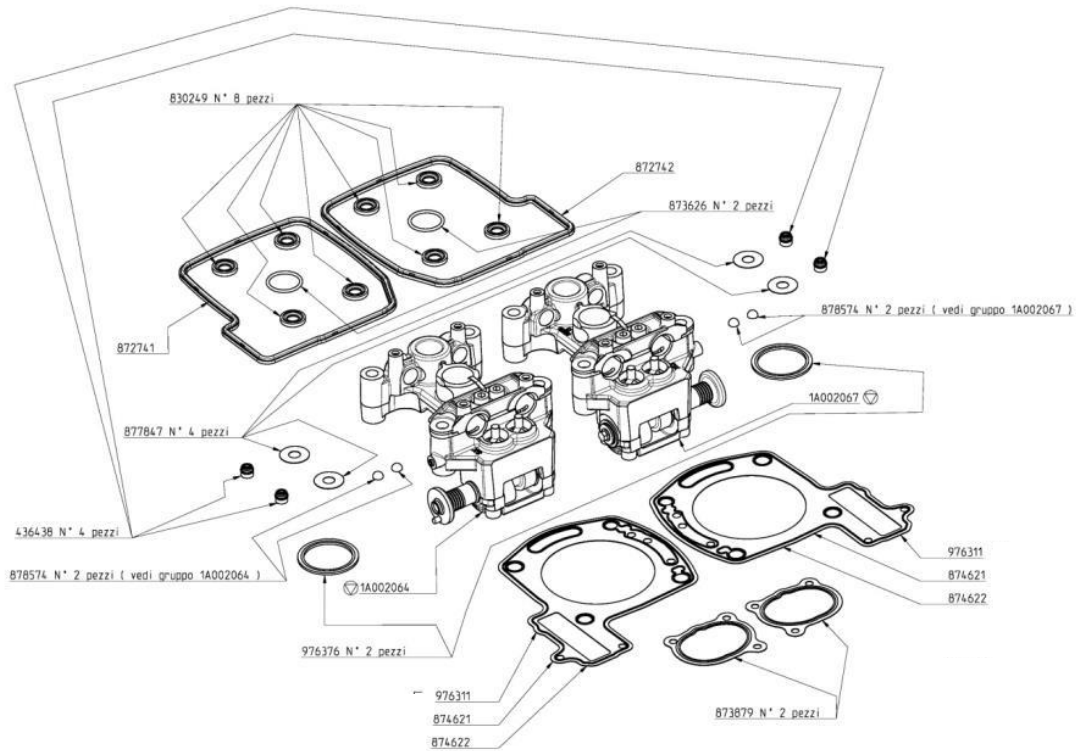
KIT C, P/N 1A002082, consists of the following components:

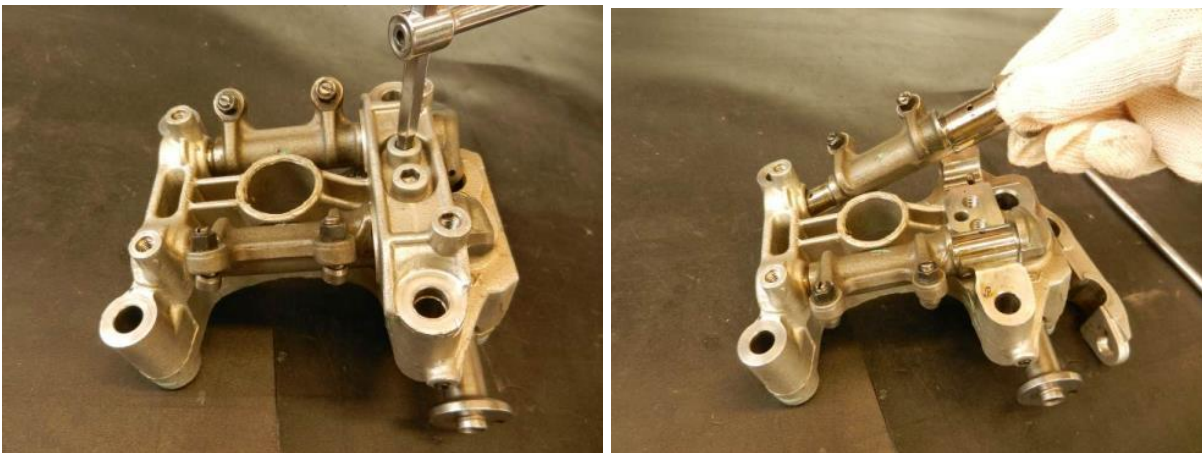
Remove the rockers mount and delicately slide them from their seat.

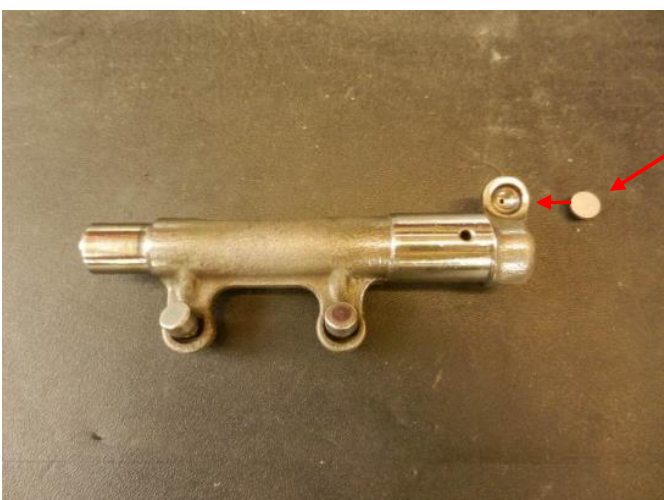
Place the pads P/N 878574 in the relative seats with the aid of a layer of grease so that they hold the position.

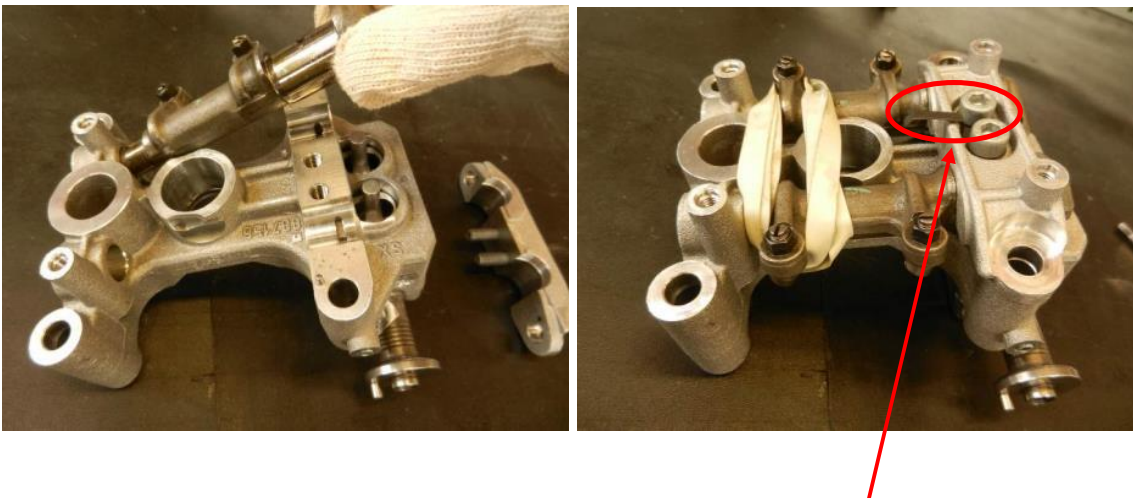
P/N B013661

Fit the old rockers in the **new** cam tower. Fasten the rocker retainer, remembering to fit the **new** ground plate **P/N B013661** included in the kit between the cam tower and the fastener screws (tightening torque 18 Nm), discarding the old ground plate.

Note: in order to ensure that the rockers stay in their seat, bind the rockers temporarily with an elastic band
